Home Report

Single Survey

Property address	61 Eastwell Road Lochee Dundee DD2 3FH
-------------------------	---

Date of inspection	10/09/2024
---------------------------	------------

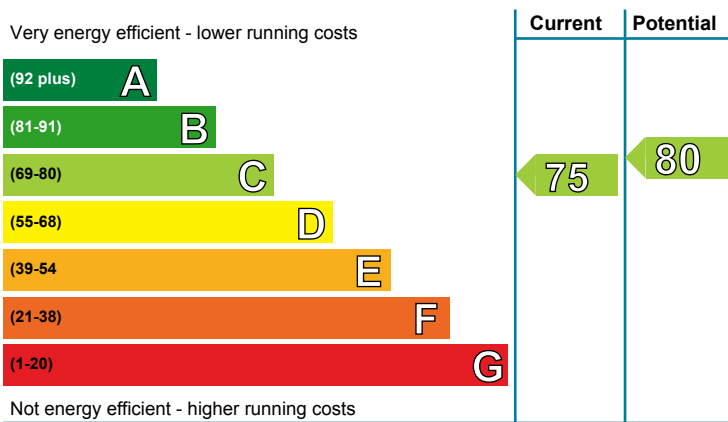
Energy Efficiency Rating

Your current rating is **band C (75)**. The average rating for EPCs in Scotland is **band D (61)**.
