Home Report

Scottish Single Survey

Property address	546 Charleston Drive Dundee DD2 4AA
Customer	Charles Quin Senior Executry
Customer address	546 Charleston Drive Dundee DD2 4AA
Prepared by	Shepherd Chartered Surveyors
Date of inspection	15/05/2024

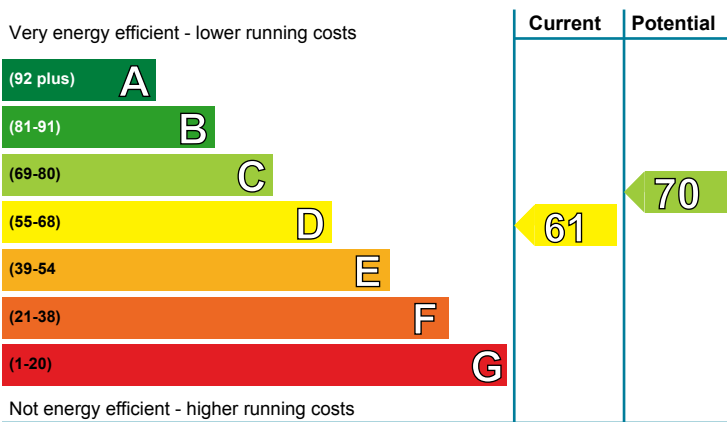
Energy Efficiency Rating

This graph shows the current efficiency of your home, taking into account both energy efficiency and fuel costs. The higher this rating, the lower your fuel bills are likely to be.

Your current rating is **band D (61)**. The average rating for EPCs in Scotland is **band D (61)**.

The potential rating shows the effect of undertaking all of the improvement measures listed within your recommendations report.

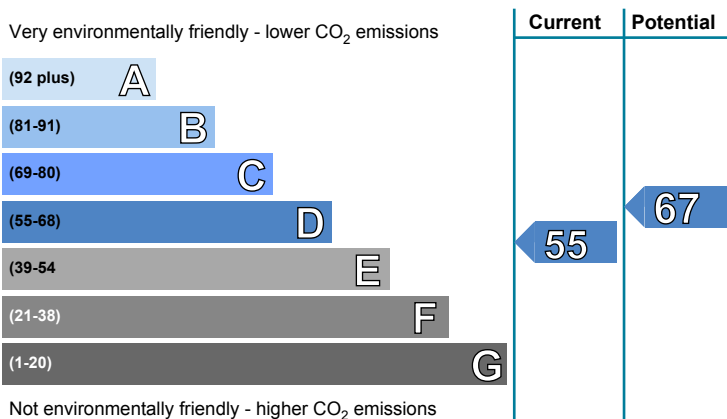
Environmental Impact (CO₂) Rating

This graph shows the effect of your home on the environment in terms of carbon dioxide (CO₂) emissions. The higher the rating, the less impact it has on the environment.
