# Home Report

# Single Survey

<b>Property address</b>	35 Camperdown Street Lochee Dundee DD2 3AR
-------------------------	---

<b>Prepared by</b>	Shepherd Chartered Surveyors
--------------------	------------------------------

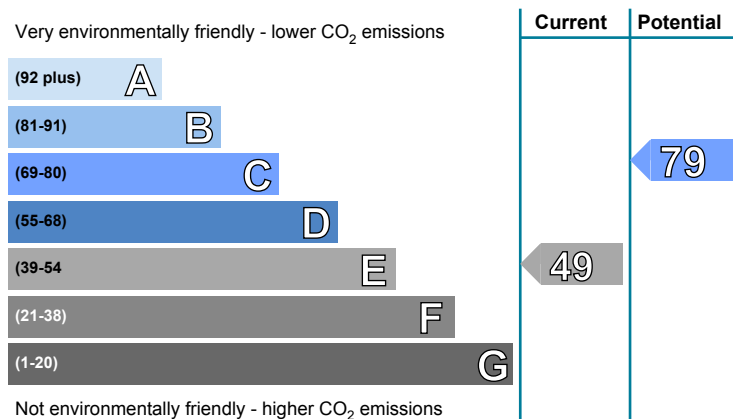
## Environmental Impact (CO<sub>2</sub>) Rating

This graph shows the effect of your home on the environment in terms of carbon dioxide (CO<sub>2</sub>) emissions. The higher the rating, the less impact it has on the environment.
