Home Report

Single Survey

Property address	2g Tullideph Road Dundee DD2 2PN
Customer	Derek Clark
Customer address	2g Tullideph Road Dundee DD2 2PN
Prepared by	Shepherd Chartered Surveyors
Date of inspection	18/12/2025

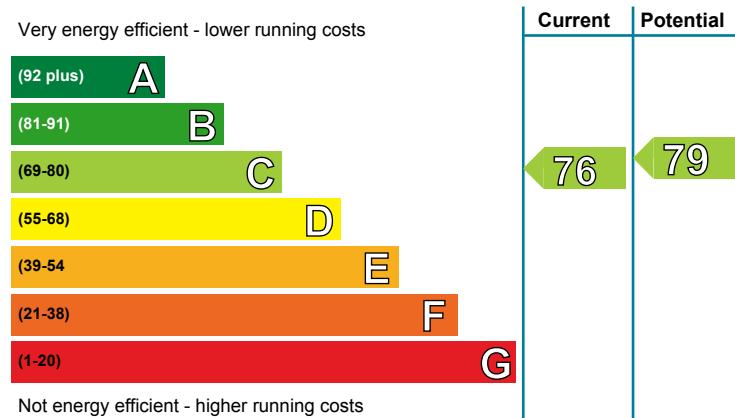
Energy Efficiency Rating

This graph shows the current efficiency of your home, taking into account both energy efficiency and fuel costs. The higher this rating, the lower your fuel bills are likely to be.

Your current rating is **band C (76)**. The average rating for EPCs in Scotland is **band D (61)**.

The potential rating shows the effect of undertaking all of the improvement measures listed within your recommendations report.

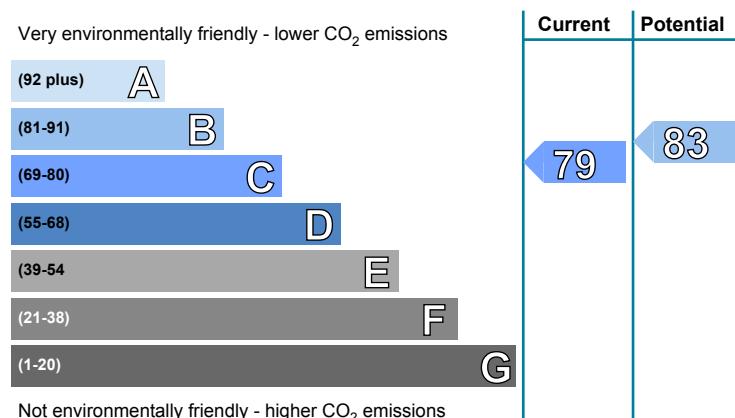
Environmental Impact (CO₂) Rating

This graph shows the effect of your home on the environment in terms of carbon dioxide (CO₂) emissions. The higher the rating, the less impact it has on the environment.
