Home Report

Single Survey

Property address	37 Heron Rise Dundee DD4 9DH
Customer	Alejandra Aranceta Garza and Lorena Sordo
Customer address	37 Heron Rise Dundee DD4 9DH
Prepared by	Shepherd Chartered Surveyors
Date of inspection	06/03/2026

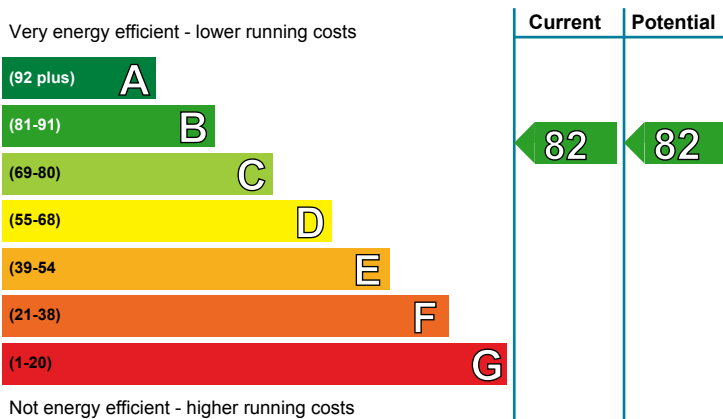
Energy Efficiency Rating

This graph shows the current efficiency of your home, taking into account both energy efficiency and fuel costs. The higher this rating, the lower your fuel bills are likely to be.

Your current rating is **band B (82)**. The average rating for EPCs in Scotland is **band D (61)**.

The potential rating shows the effect of undertaking all of the improvement measures listed within your recommendations report.

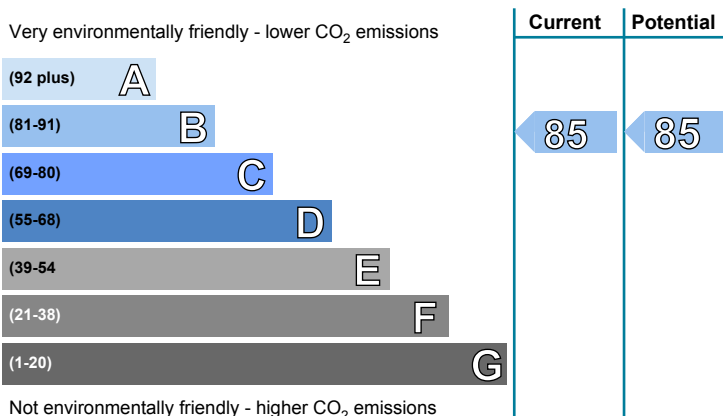
Environmental Impact (CO₂) Rating

This graph shows the effect of your home on the environment in terms of carbon dioxide (CO₂) emissions. The higher the rating, the less impact it has on the environment.
