# Home Report

# Energy Performance Certificate (EPC)

FLAT 2/2 , 377 PAISLEY ROAD WEST, GLASGOW, G51 1LX

# Single Survey

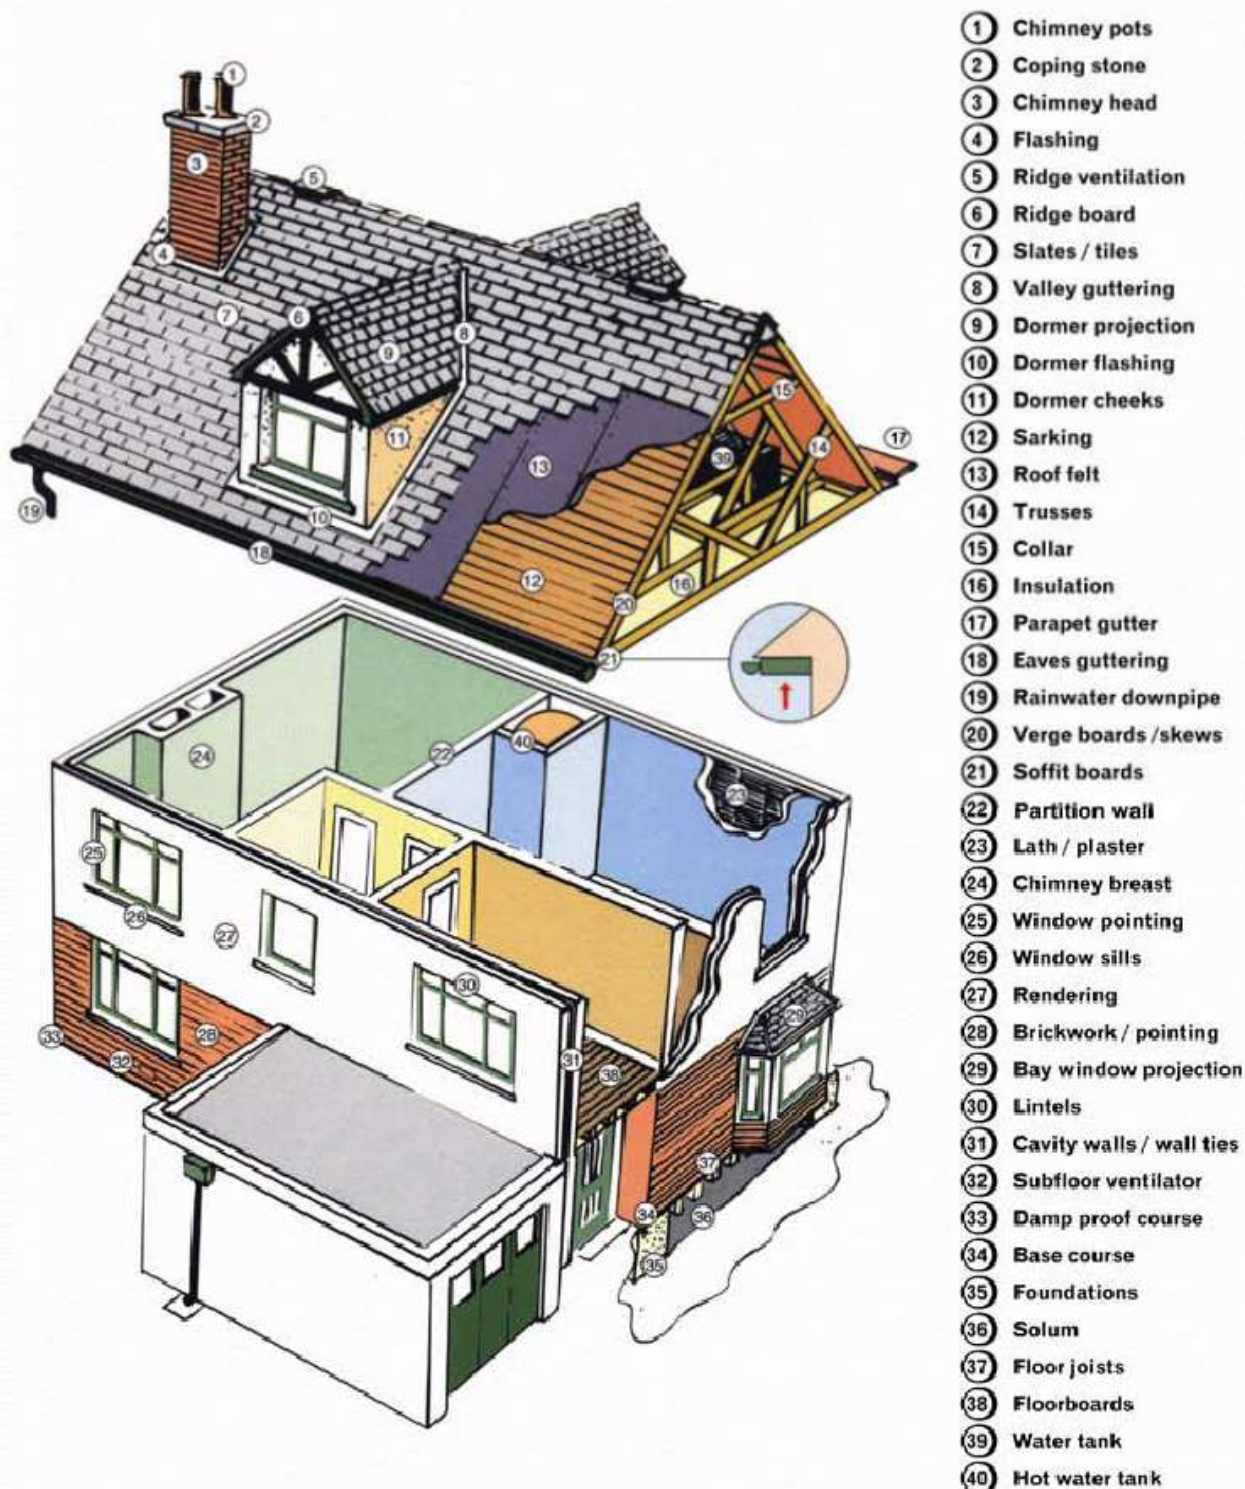
## Sectional Diagram showing elements of a typical house

Reference may be made in this report to some or all of the above component parts of the property. This diagram may assist you in locating and understanding these items.
